Barrel Hybrid Production

T. Kohriki, Y. Ikegami, Y. Unno, et al. KEK

SCT week, Tuesday, 2 Dec 2003

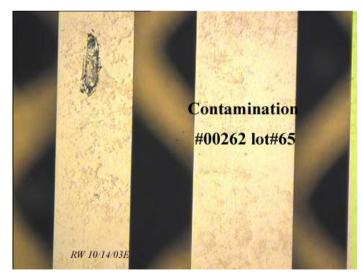
- Gold and PA pads contamination
 - In the recent lot#64/65 deliveries, worse bondability on gold pads in hybrids were reported.
 - Reported more often cleaning of wedge in bonding gold pads in the US
 - Color of gold pads more orange than yellow
 - Contamination on PA of the hybrids also observed
 - Also, bad bondability at UCSC while bondable at LBL on PA

Gold pads color difference (LBL)

- Argon plasma cleaning
 - The contamination is easily removed with a short time application of Argon plasma cleaning
 - Unfortunately, plasma cleaning of PA showed detrimental effect on the PA bondability
 - In future shipments, hybrid surface will be plasma cleaned with PA covered.
 - PA cover will be removed and alcohol wipecleaning when contamination is observed. No PA cover in the shipping

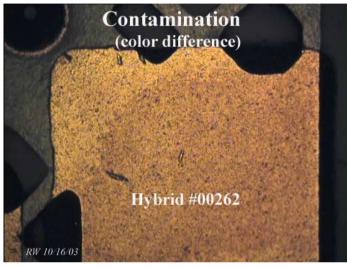
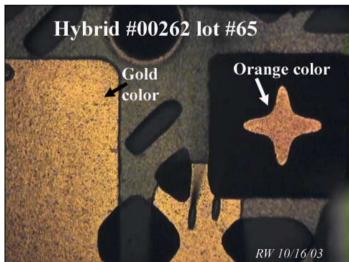
PA pads contamination in the same hybrid

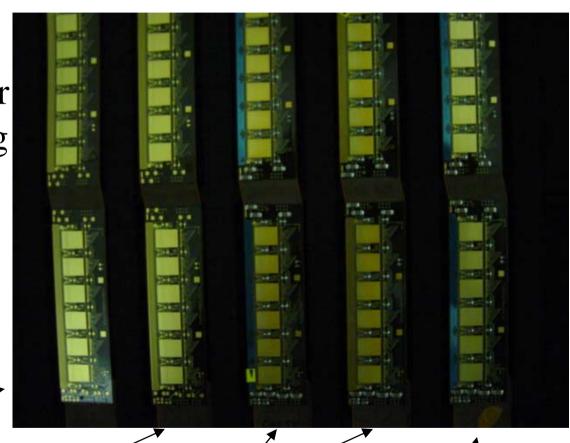
Coloration was after SMD solder and flux cleaning

- No faulty Ni plating
 - If faulty Ni plating, Cu migration may deteriorate bonds in long term
- Most plausible source is residue of adhesive
 - of protection film during the bridge-flex gluing
 - which absorbed solder flux water and colored or absorbed colored flux water in the cleaning bath (accidentally contaminated)
