CNGS Run 2007: Radiation Issues

CNGS Secondary Beam Working Group

CNGS (CERN Neutrino Gran Sasso)

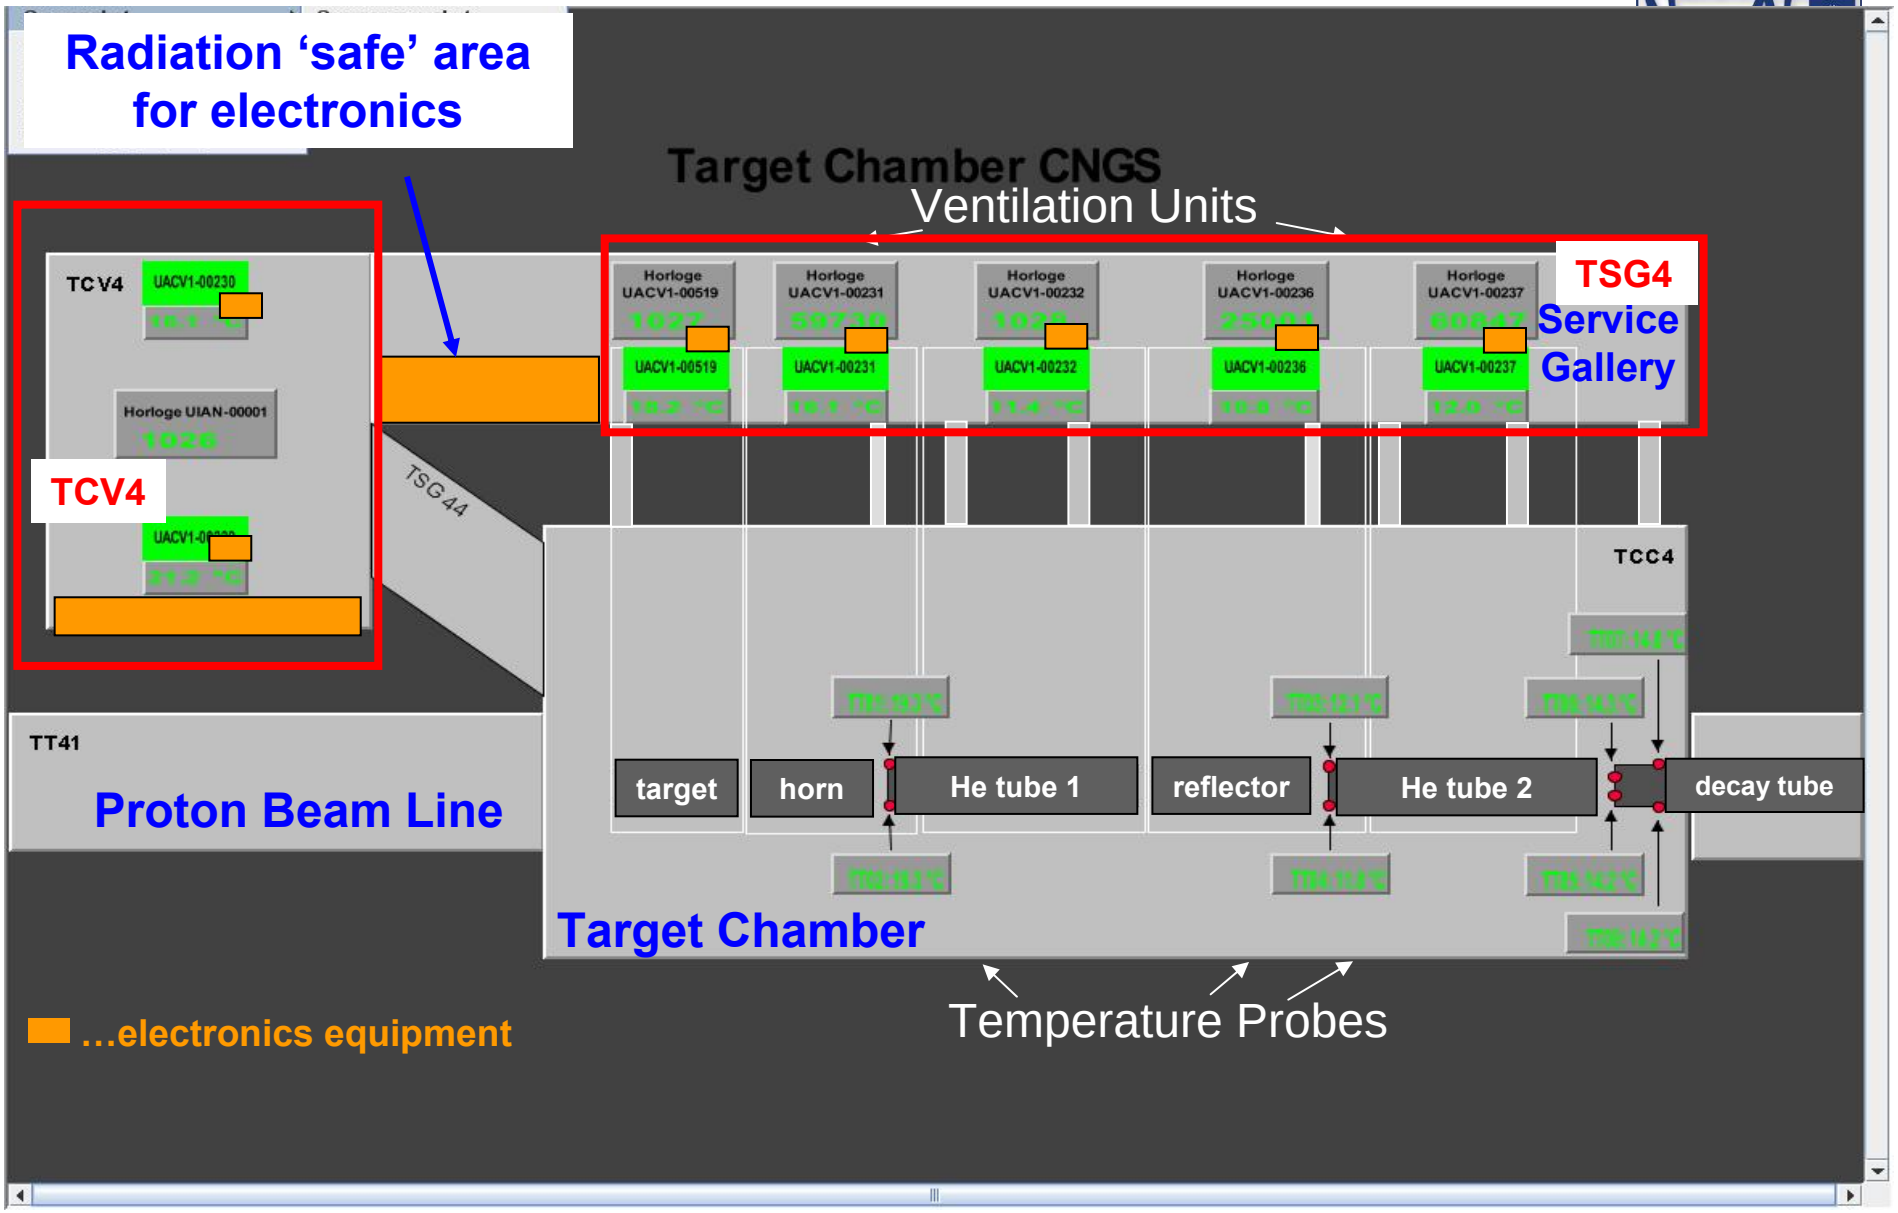
CNGS Electronics Layout

- **Successive failures in the ventilation system**
  - **Strong efforts made by TS/CV to save the situation**
- **Physics run stopped on Monday 22 October 2007, 5 days ahead of time.**
  - **Failures in the ventilation system control electronics that blocked switching to access mode in a safe manner**

→ intolerable for an INB facility

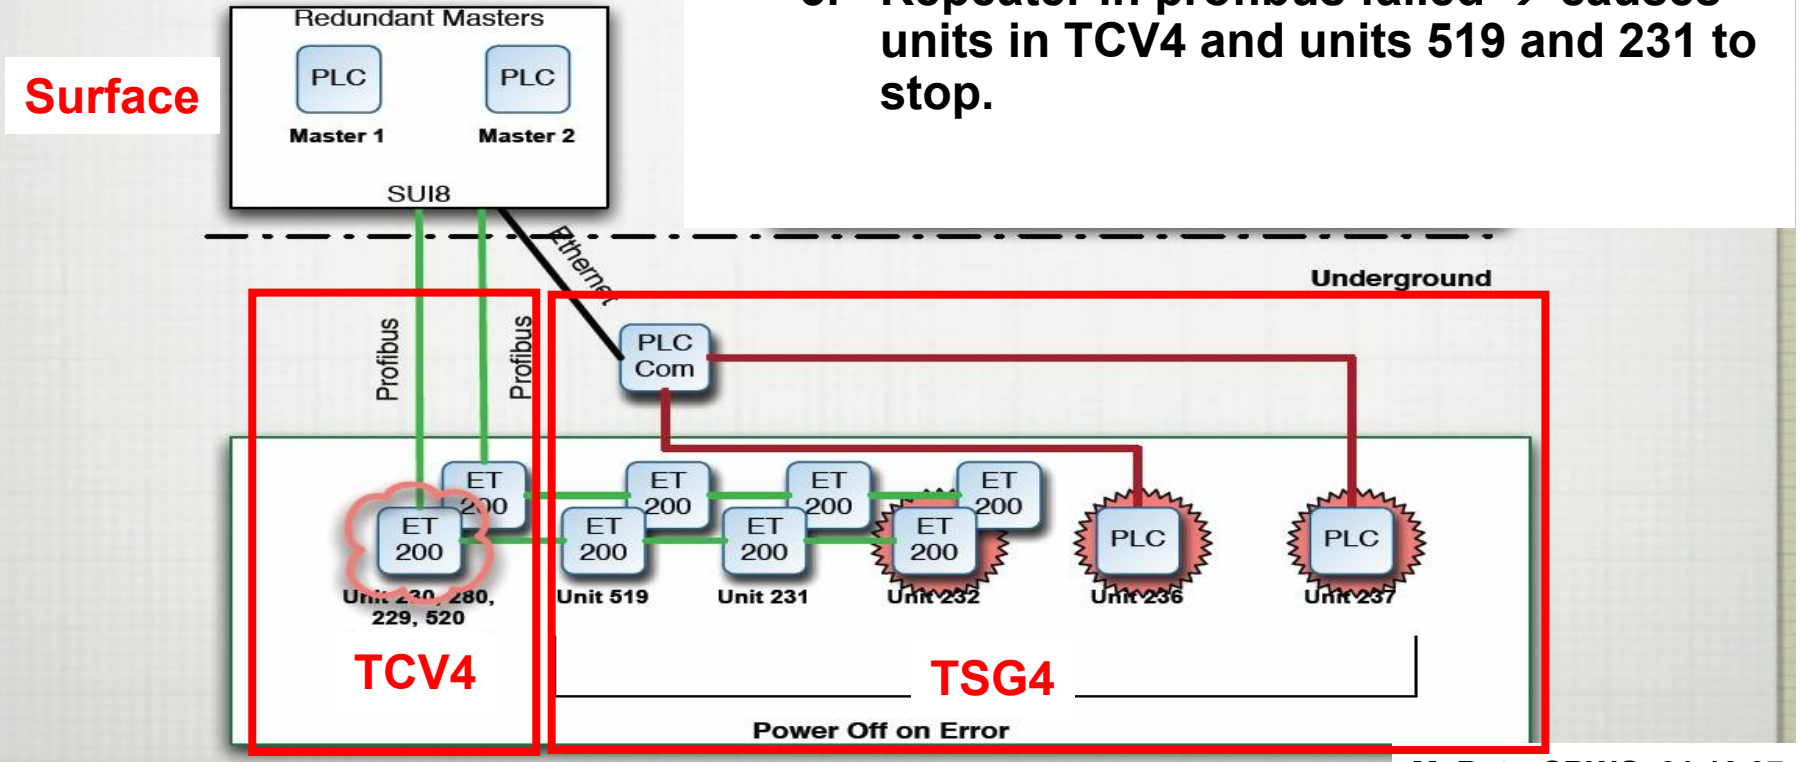
Incidents of CNGS Ventilation System

3 x Incidents:

SEU in ventilation electronics: Loss of Control and Communication

1. & 2.) Electronics of PLC Com, PLC unit 237 and remote I/O in unit 232 failed,
3. Repeater in profibus failed → causes units in TCV4 and units 519 and 231 to stop.

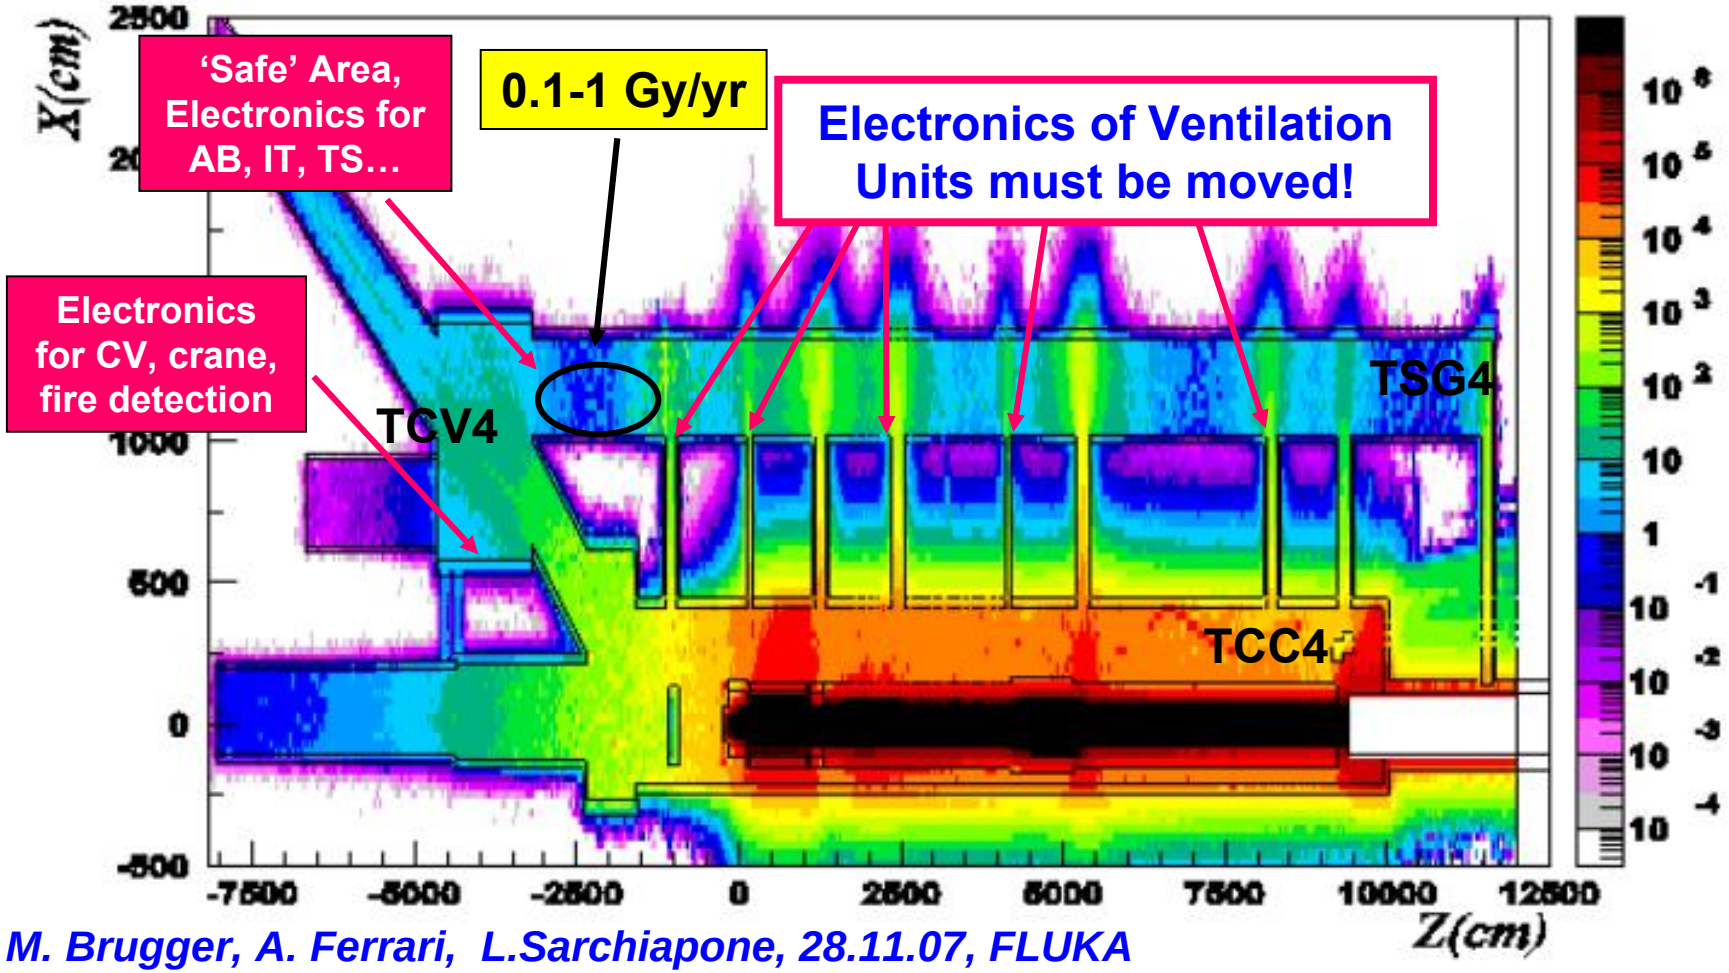
Expected Dose Levels

Gy/yr for a nominal CNGS year of 4.5 10^{19} pot

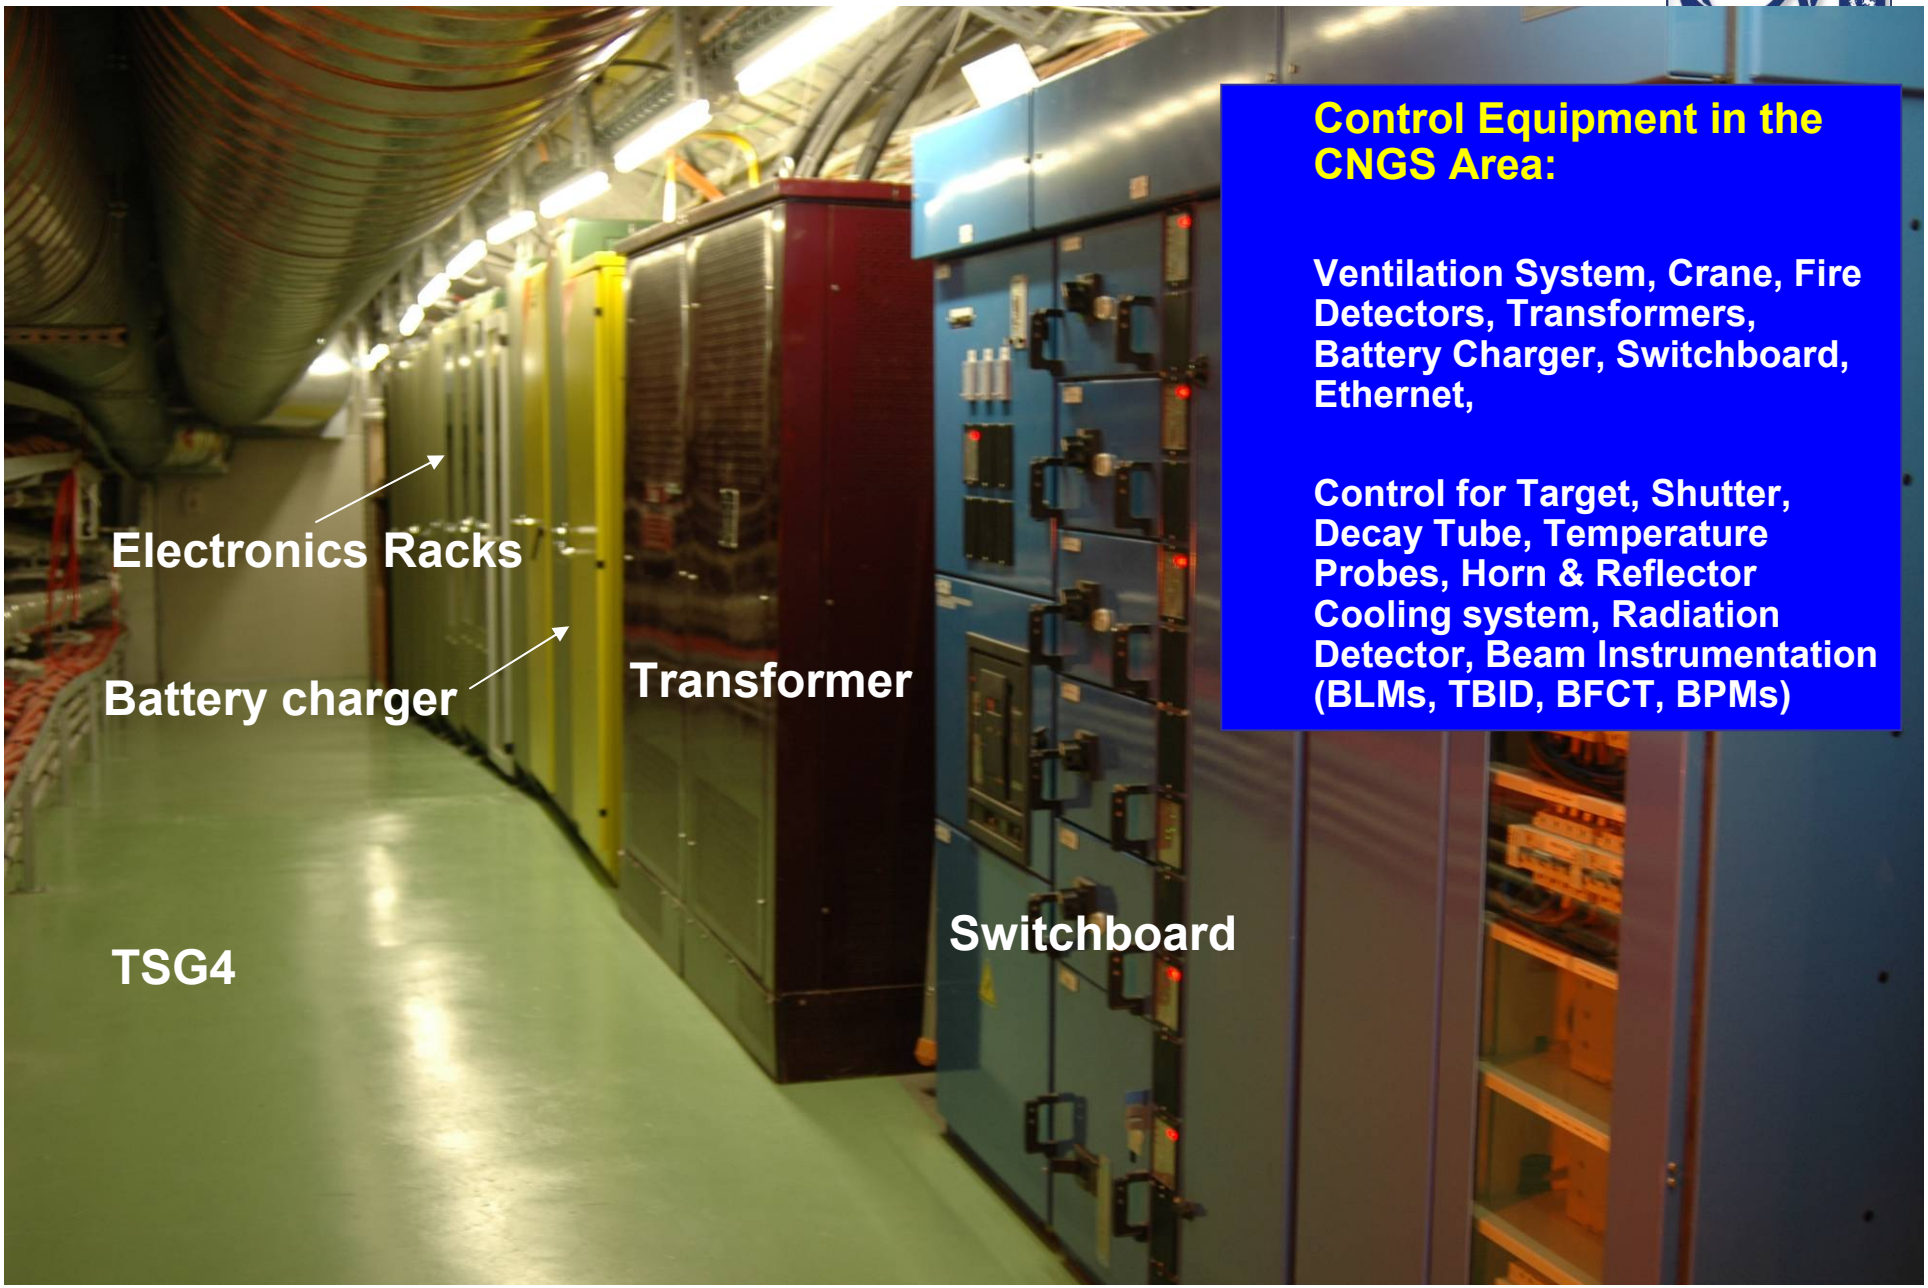
‘Safe’ Area for Electronics

Control Equipment in the CNGS Area:

Ventilation System, Crane, Fire Detectors, Transformers, Battery Charger, Switchboard, Ethernet,

Control for Target, Shutter, Decay Tube, Temperature Probes, Horn & Reflector Cooling system, Radiation Detector, Beam Instrumentation (BLMs, TBID, BFCT, BPMs)

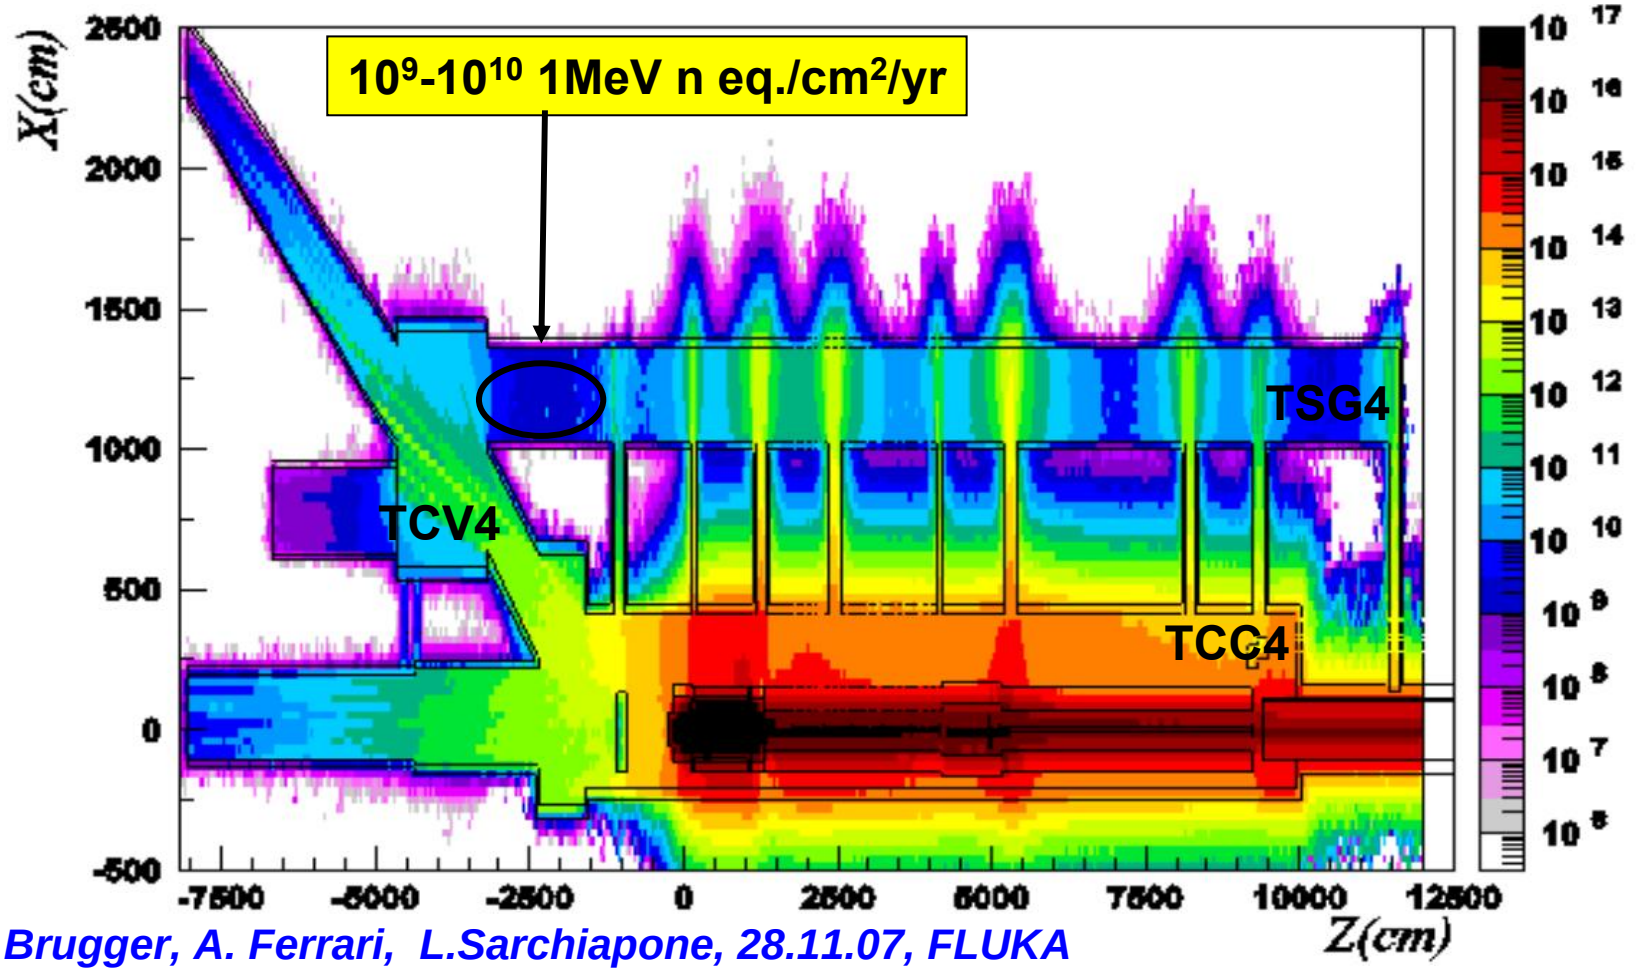
Expected Neutron Fluence

1 MeV eq. neutron fluence (cm^{-2} yr^{-1}) for a nominal CNGS year of 4.5 10^{19} pot

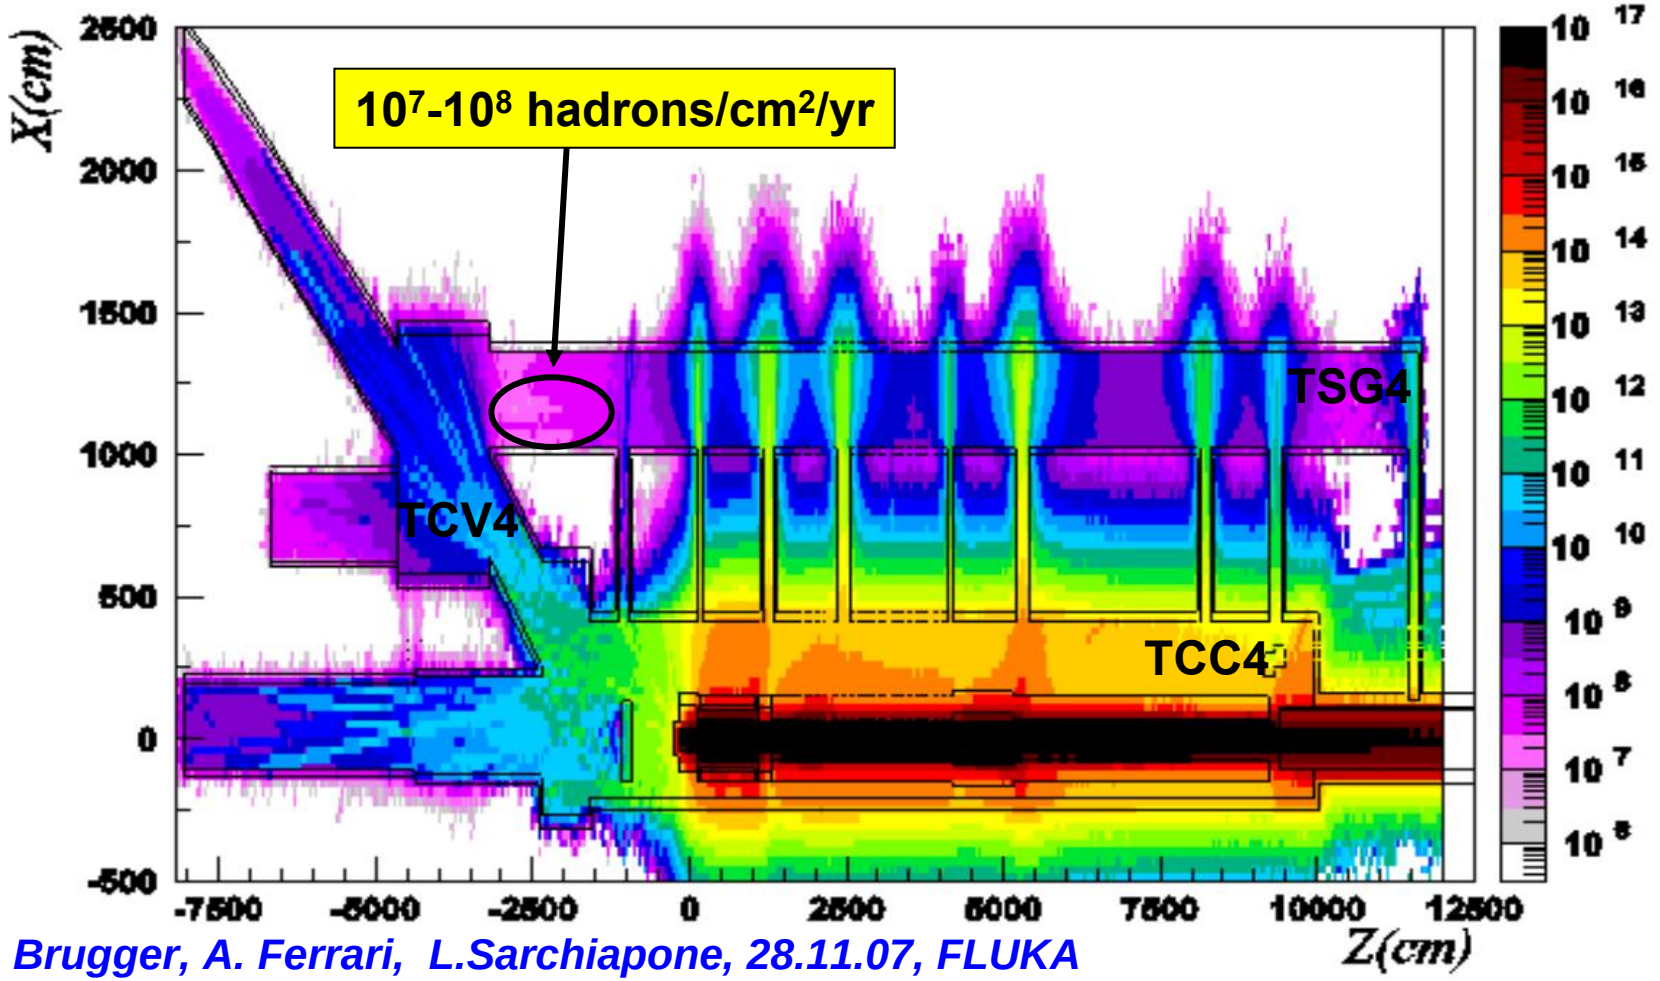
Expected High Energy Hadron Fluence

Energetic (> 20 MeV) hadron fluence (cm^{-2} yr^{-1}) for a nominal CNGS year of 4.5 10^{19} pot

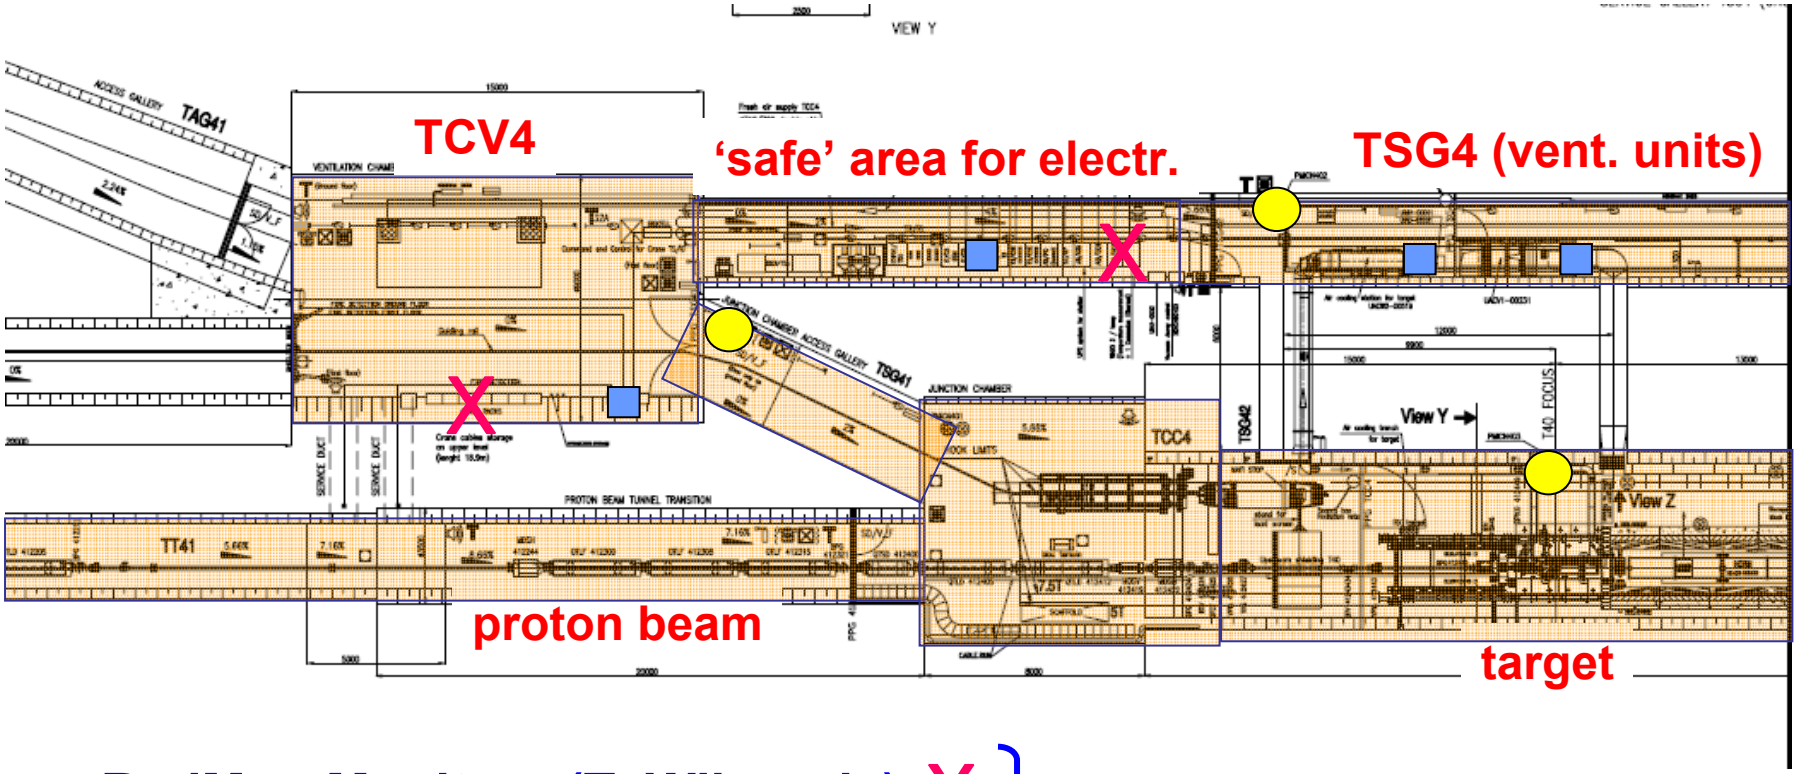
Radiation Measurements

- RadMon Monitors (T. Wijnands) X
- TLDs (SC/RP) ■

} Measurements only during last day of operation: $7.2 \cdot 10^{16}$ pot

- PMI detectors (SC/RP) ●

- **Detailed analysis and comparison between the simulations and measurements ongoing**
  - **The numbers basically agree:**
    - **Some better understanding of RadMon monitor sensitivity needed.**
- **No major changes in simulations (updated geometry) with respect to previous calculations → confirmed by measurements**
