Status report on TTCrx chip

A. Marchioro, P. Moreira, T. Toifl 29-601

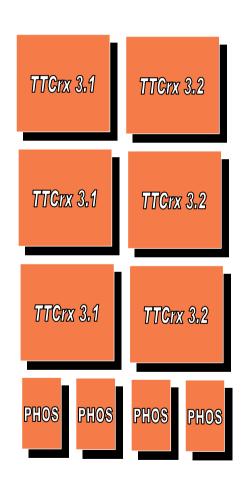
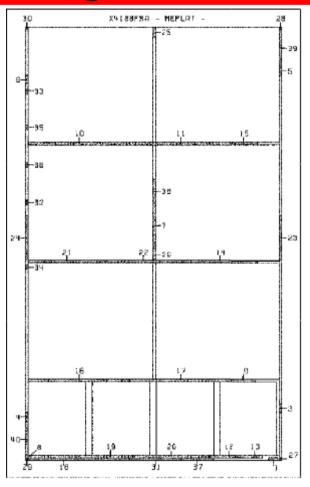
Engineering Run: August 2000

- Eight wafers in engineering run
- Version 3.1:
 - » No modifications
 - » Number of ASICs: 1650
 - » Old test socket: Yield ~75% (tested 208)
 - » New test socket: Yield 80% (tested 480)
- Version 3.2:
 - » Tolerance to PIN-SEU improved
 - » Number of ASICs: 1550
 - » Yield ~70% (tested 690, old test socket)
