## VIBRATION STUDIES OF THE STANFORD LINEAR ACCELERATOR<sup>†</sup>

J. L. Turner, C. Adolphsen, G. B. Bowden, F. J. Decker, S. C. Hartman, S. Matsumoto, G. Mazaheri, D. McCormick, M. Ross, R. Stege, S. Virostek, M. Woodley  
Stanford Linear Accelerator Center, Stanford University, Stanford, CA 94309 USA

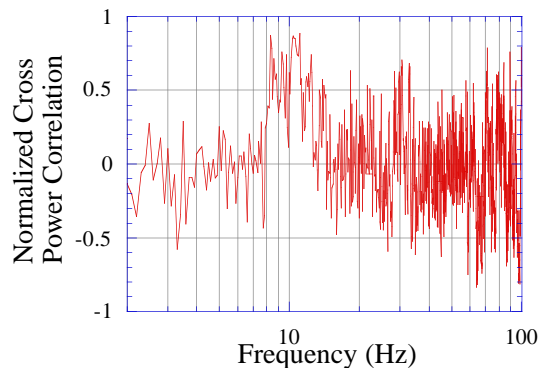
Figure 1. Spectrum of normalized cross power correlation of vertical motion of two quadrupoles.

Vertical motion of accelerator structures was measured at 1 micron rms, and thought not to be a problem for SLC beams. Quadrupole vertical motion was about 250 nanometers rms, enough to be a problem [2]. Correlation between the motions of two quadrupoles separated by 12 meters was high in the 8-14 Hz range (see figure 1) but not elsewhere in the spectrum.

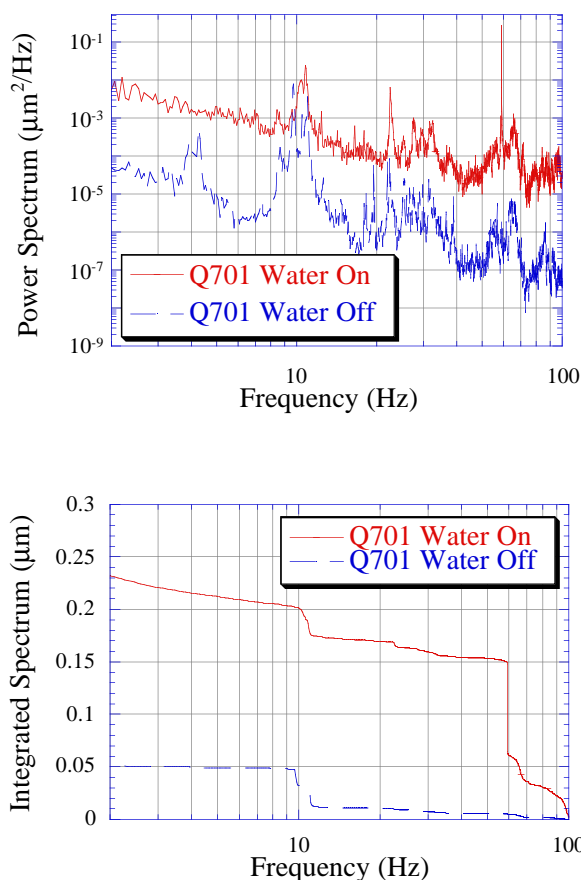
Figure 2. Quadrupole motion spectrum (top) and integrated spectrum (bottom) with accelerator cooling water on and off.

Turning off water to the quadrupoles themselves had little affect, but turning off the water to the adjacent accelerator structures lowered vibration of the quadrupoles from about 250 nanometers rms to about 60 nanometers rms (see figure 2). Thus most of the quadrupole motion is due to the vibrations that are caused by the cooling water. Much of the motion is at 59 Hz (see figure 2 bottom plot) which can be seen in the jitter of the beam orbits [3]. The 59 Hz motion is believed to be due to the accelerator water pump impeller rotating at 59 Hz. The quadrupole motion in the 8-14 Hz

range, however, was not reduced dramatically with the water off (see figure 2).

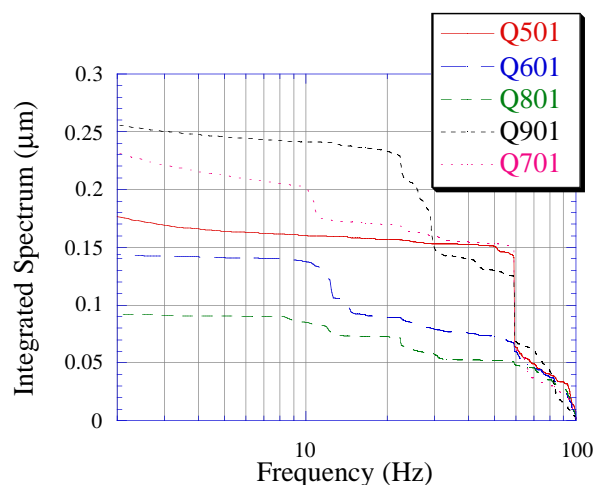
Figure 3. Integrated vertical motion of five quadrupoles with the accelerator water on.

Not all quadrupoles exhibit the same behavior. Figure 3 shows some examples of the integrated spectrum. Note that the fraction of 8-14 Hz motion and 59 Hz motion differs. Oscillations at 28-30 Hz dominate the spectrum of quadrupoles that have upright supports (the so called matching quadrupoles, see Q901 in figure 3) even with the water off. These quadrupoles also have a spike at 59 Hz that disappears when the accelerator water is turned off.

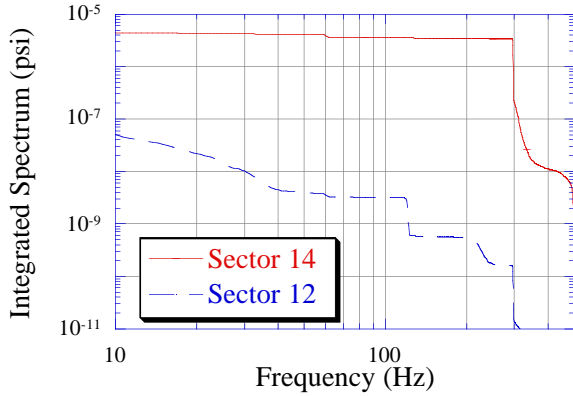
Figure 5. Integrated water pressure variations from two accelerator water systems.

To study the difference, the pipe vibration near the pump was measured in sector 14. The 59 Hz motion was observed. Also, a pressure transducer was used to measure the time variation of the pressure at sector 12 and 14. The pump rotates at 59 Hz, and pump impellers have five vanes which create a large contribution at 295 Hz. Figure 5 shows the integrated spectra of the pressure variations.

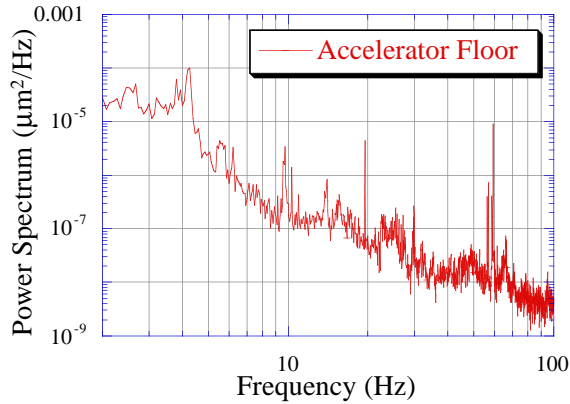
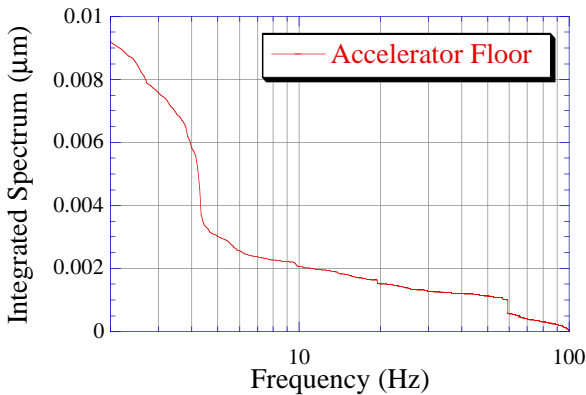
Figure 6. Spectrum and integral of vertical motion on the floor of the accelerator tunnel (about 35' below ground [4]).

Finally, measurements of the accelerator floor motion were made. Figure 6 shows an example. Integrated values ( $>2$  Hz) between 9 and 35 nanometers were observed on different days.
